West Bay Coastal Defence and Harbour Improvement Scheme

Physical Model Study

Report EX4064
January 2000

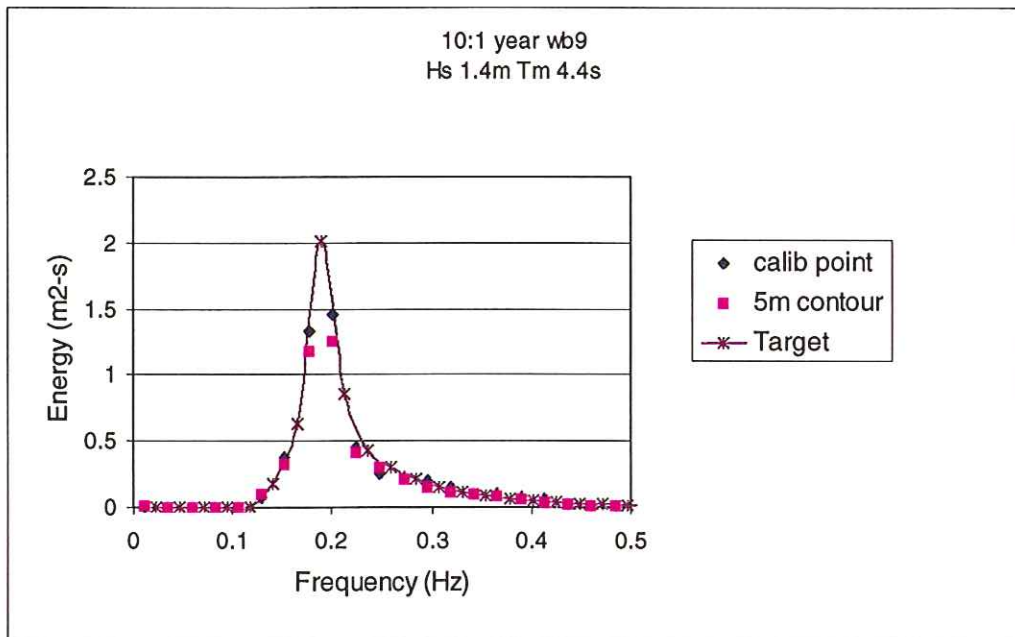
Figure 8 Typical wave spectra, waves from 160°N, 10:1 year return period

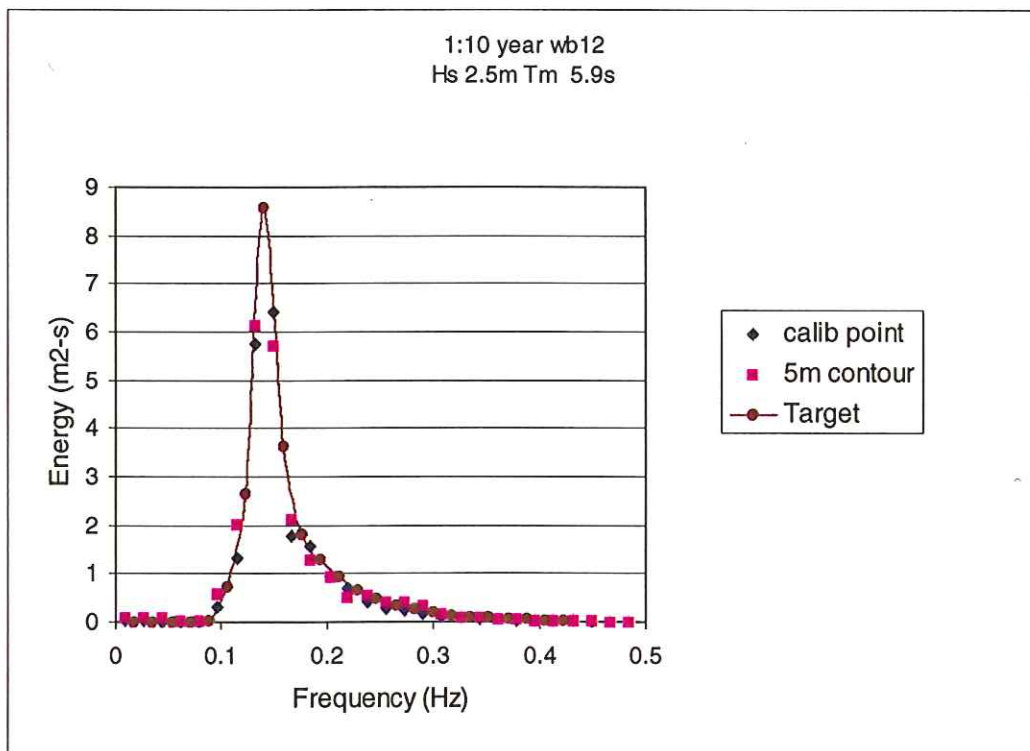
Figure 9 Typical wave spectra, waves from 160°N, 1:10 year return period

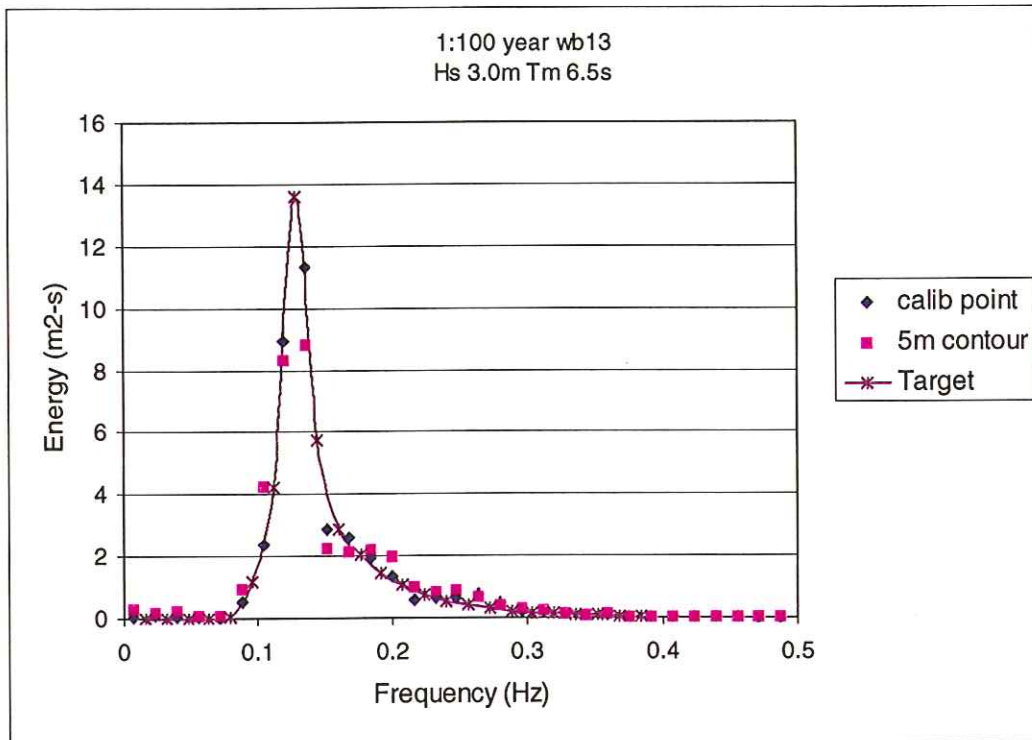
Figure 10 Typical wave spectra, waves from 160°N, 1:100 year return period

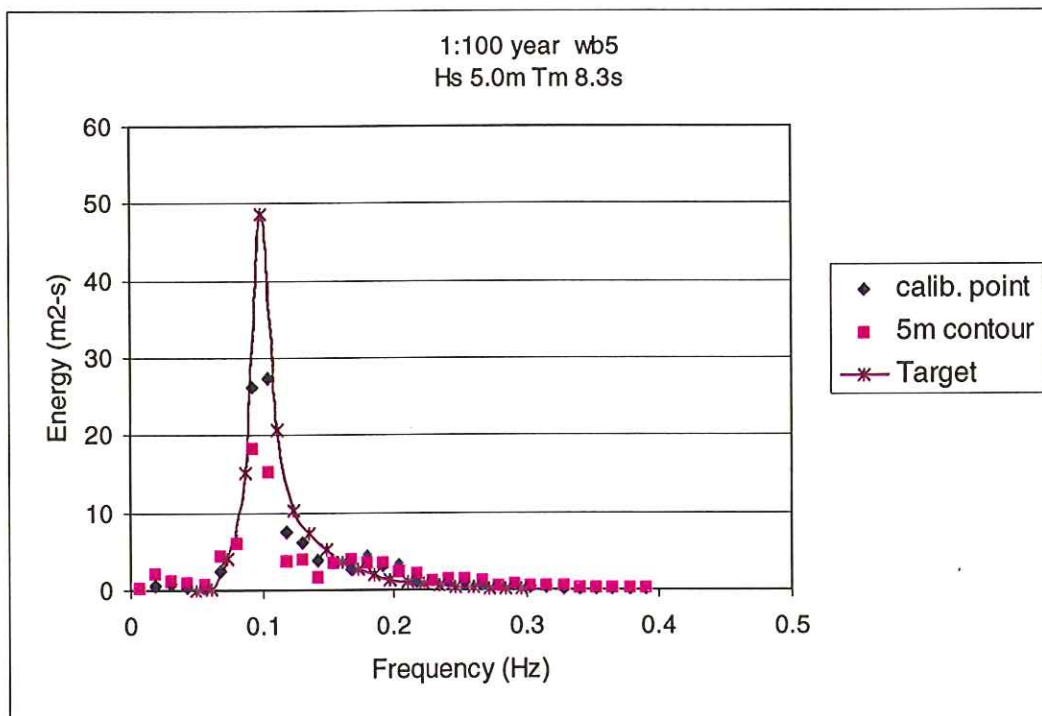
Figure 11 Typical wave spectra, waves from 220°N, 1:100 year return period

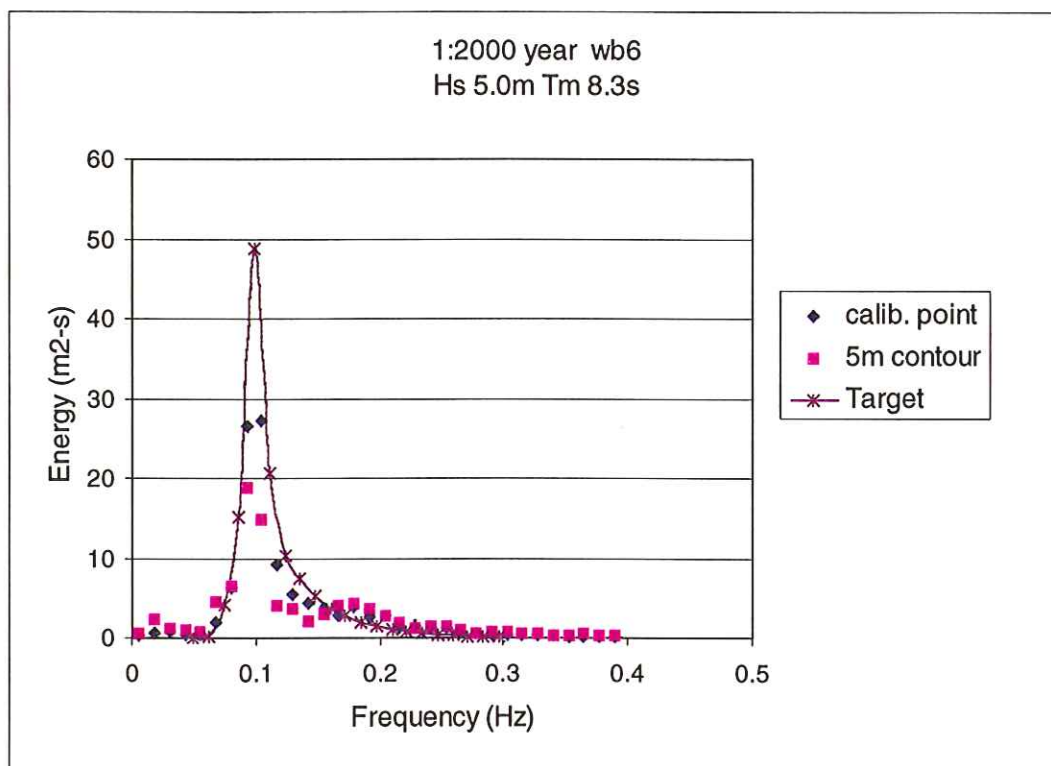
Figure 12 Typical wave spectra, waves from 220°N, 1:2000 year return period

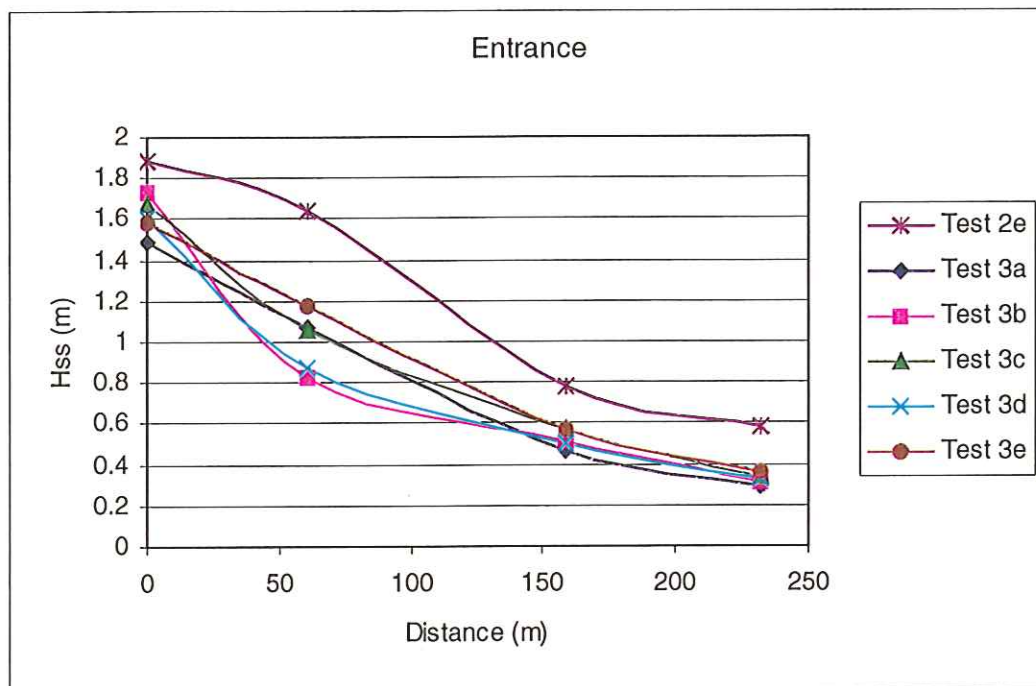
Figure 18 A comparison of wave heights along the harbour entrance channel, 1:1 year condition, waves from 160°N, existing and inner harbour modifications

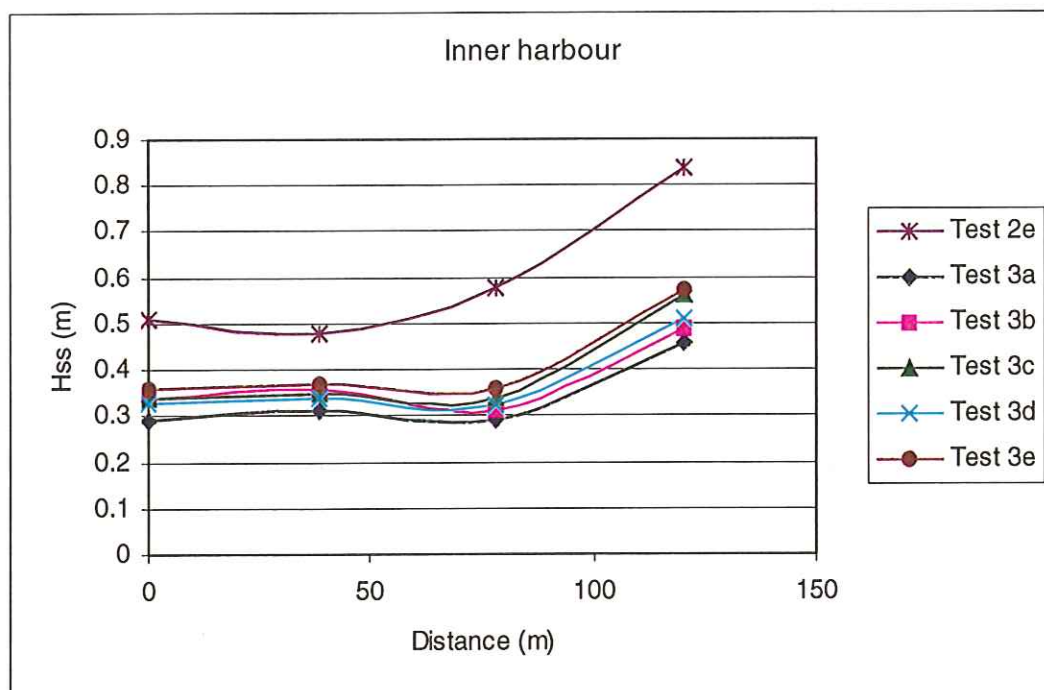
Figure 19 A comparison of wave heights within the inner harbour, 1:1 year condition year condition, waves from 160°N, existing and inner harbour modifications

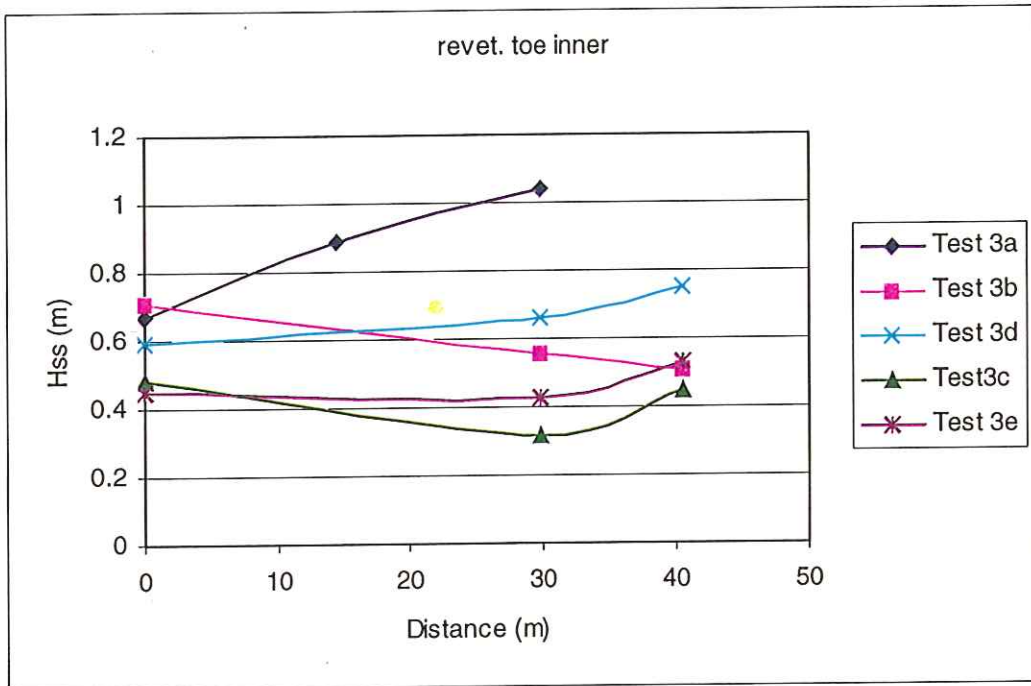
Figure 20 A comparison of wave heights in the outer harbour, 1:1 year condition, waves from 160°N, inner harbour modifications

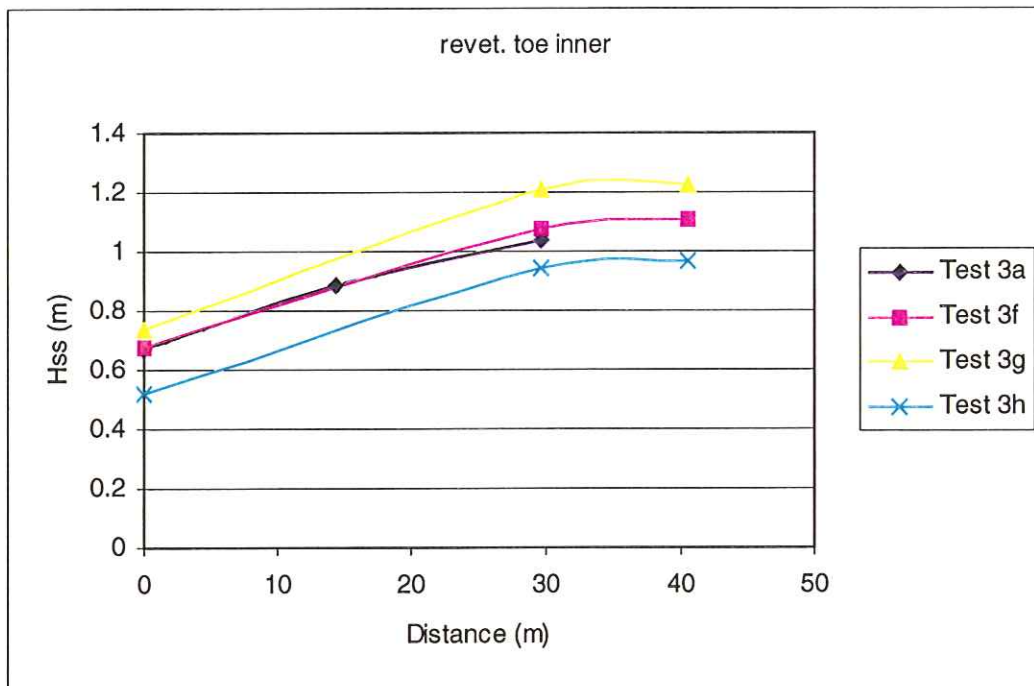
Figure 23 A comparison of wave heights in front of the outer harbour revetment, 1:1 year condition, waves from 160°N, entrance modifications

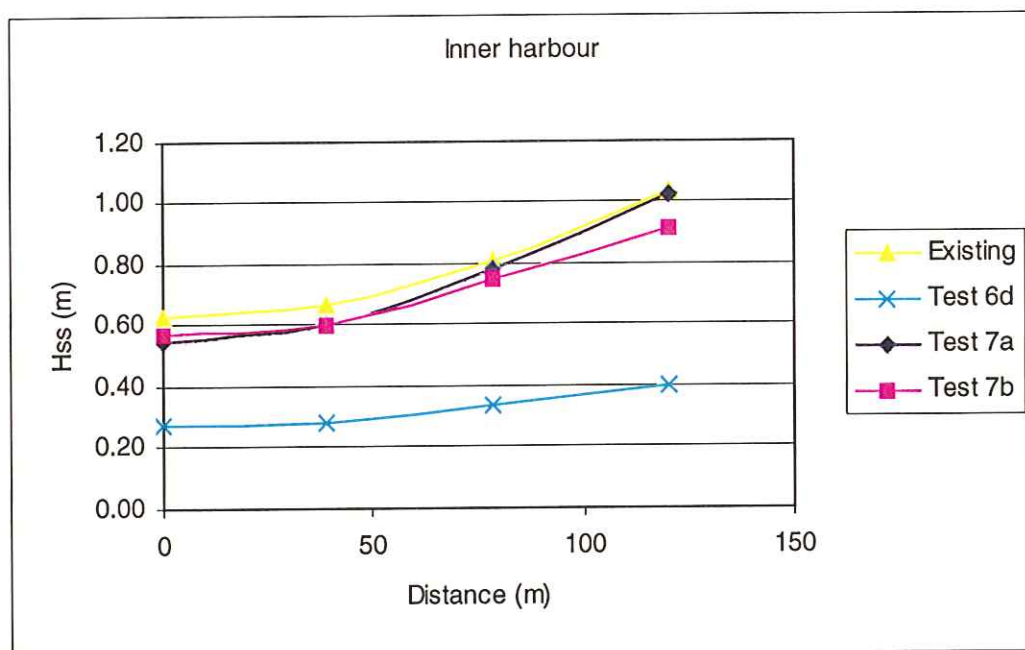
Figure 25 A comparison of wave heights within the harbour, 1:10 year condition, waves from 220°N, existing and temporary works

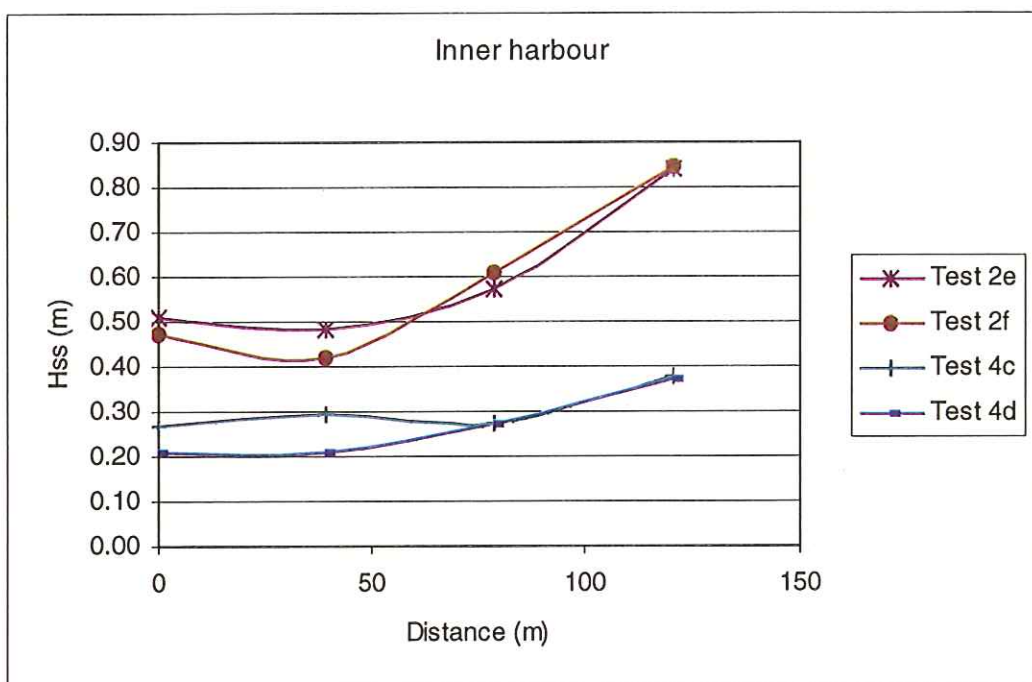
Figure 27 A comparison of wave heights within the harbour, 1:1 and 1:10 year condition, waves from 160°N, existing and layout assessed during Test Series 4

28. Similarly the waves conditions within the inner harbour are shown in Figures 27 and 29. For the preferred option, wave heights within the harbour were significantly reduced, and as a consequence overtopping discharges around the harbour walls were also reduced.

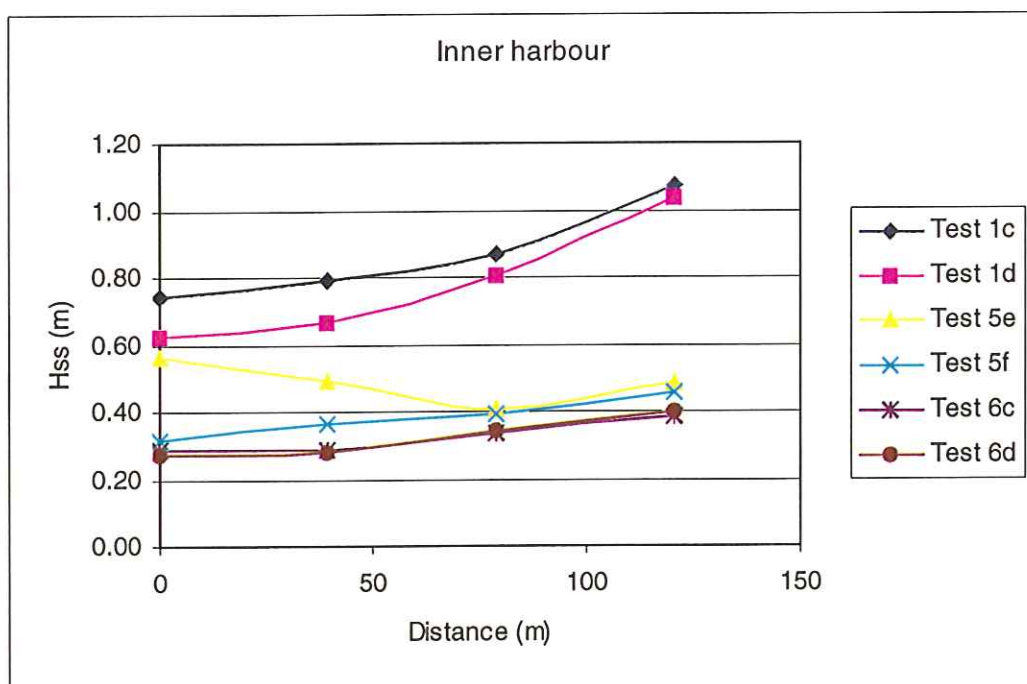
Figure 29 A comparison of wave heights within the harbour, 1:1 and 1:10 year condition, waves from 220°N, existing and proposed layouts

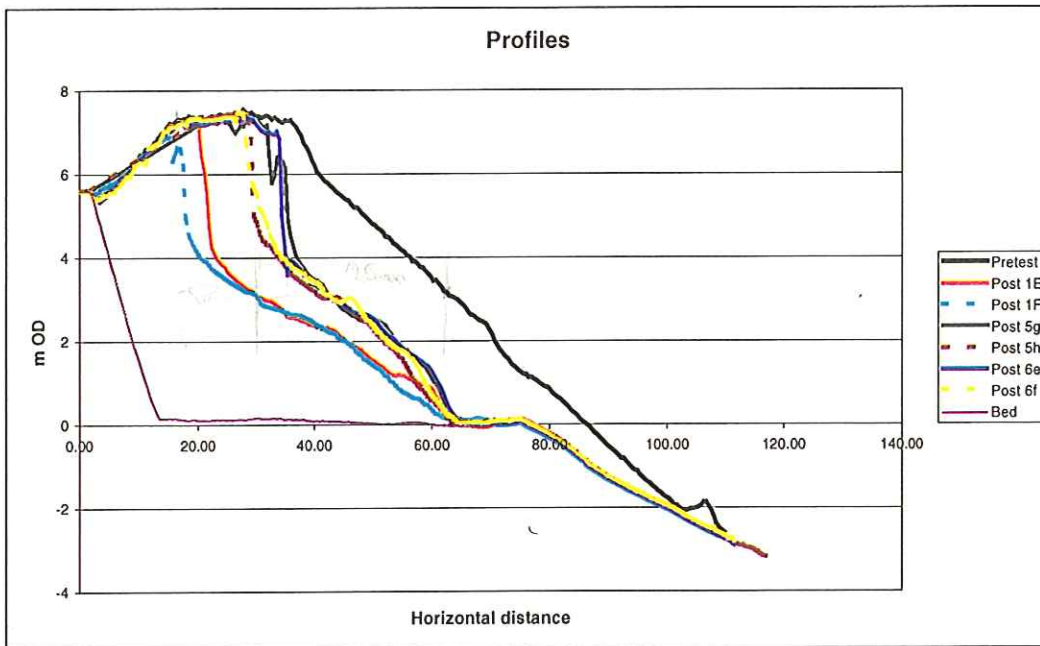
Figure 30 A comparison of beach profiles for the 1:100 and 1:2000 year conditions for waves from 220°N, existing and proposed layouts *after 3 hrs* *185.7 mins*

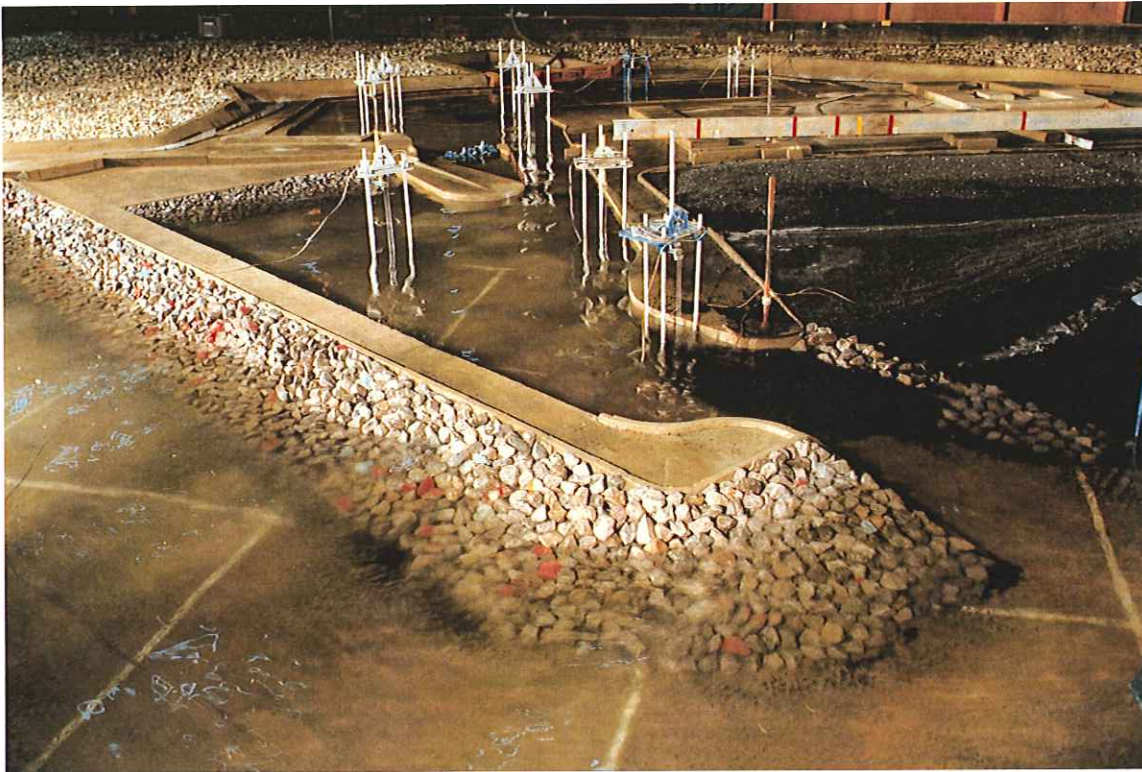
Plate 3 View of the physical model, Test Series 4 and 5

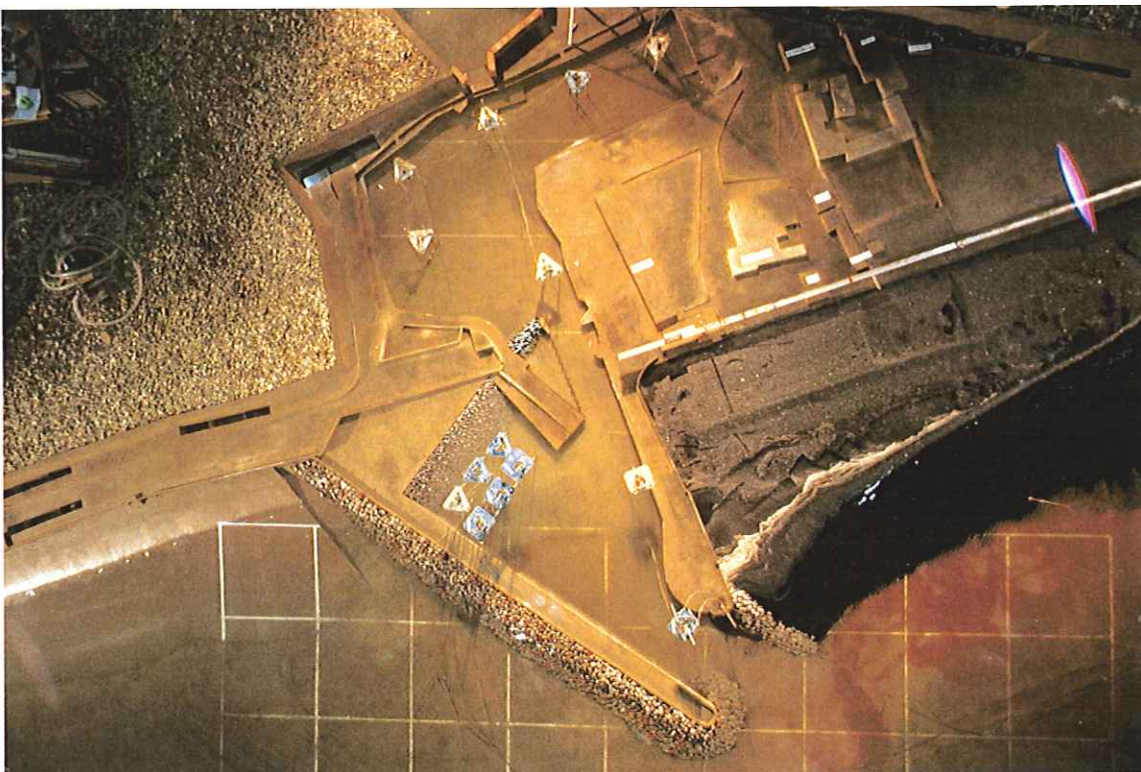
Plate 4 Rock armoured roundhead, Test 3a

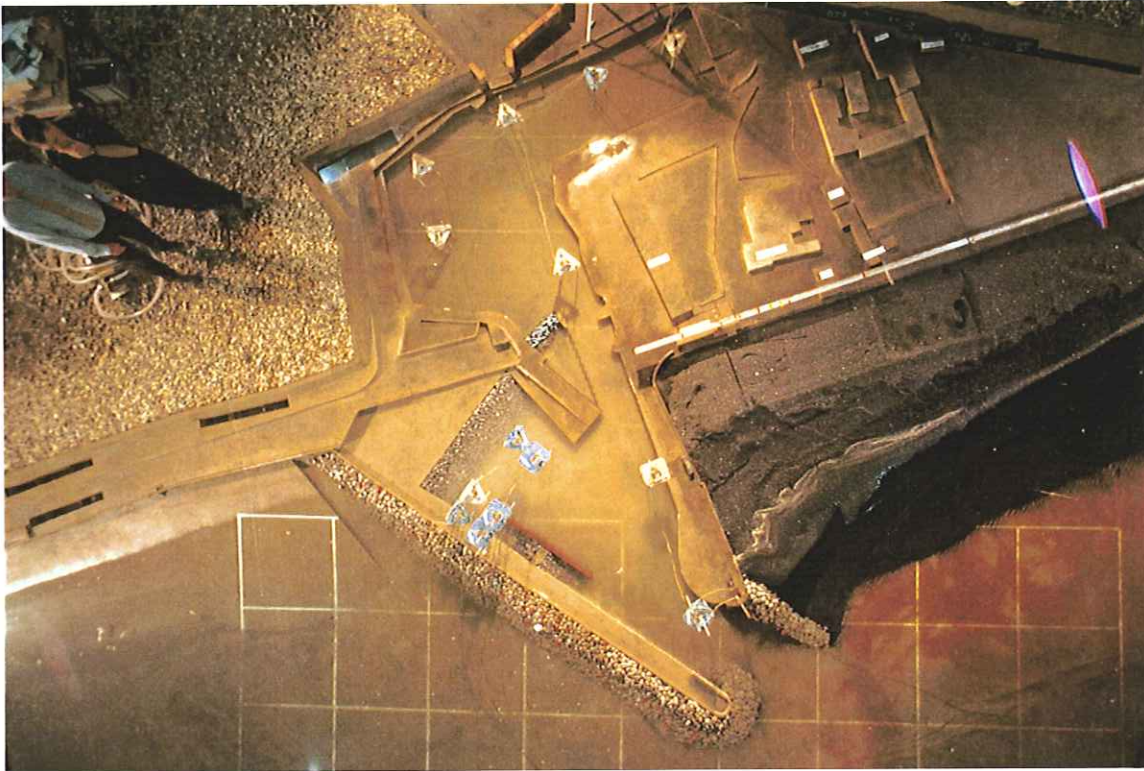
Plate 5 Outer harbour modification, Test 3b

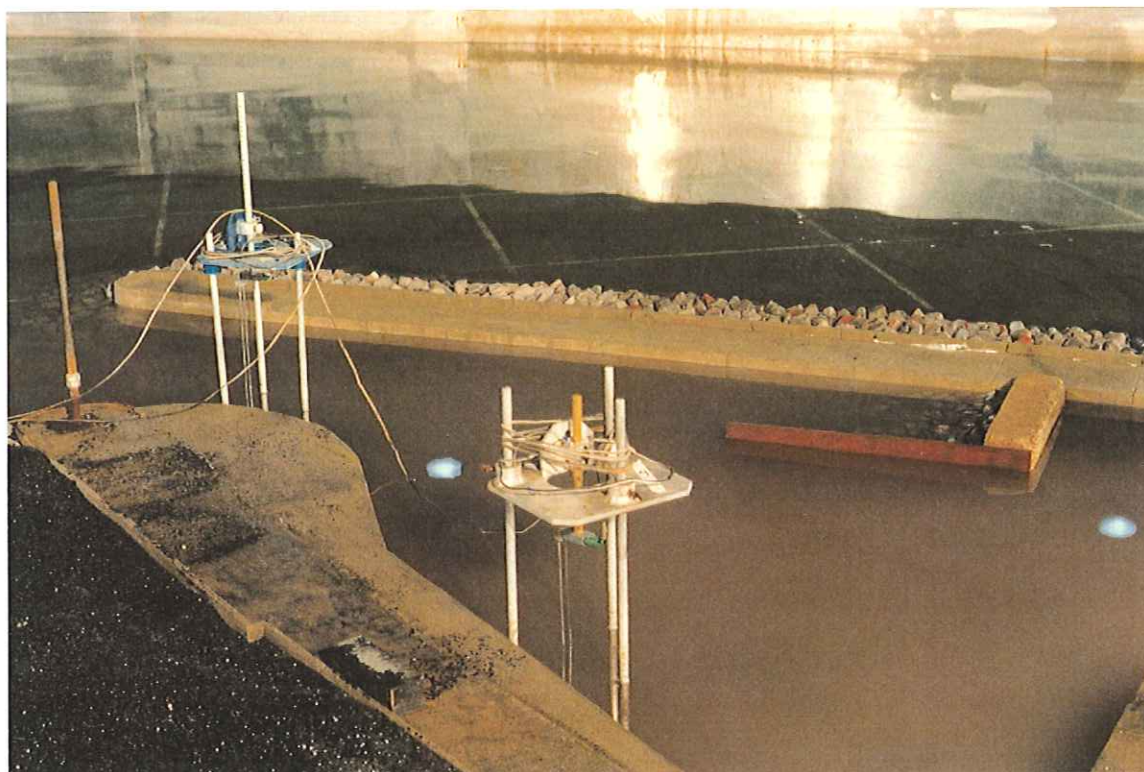
Plate 6 Outer harbour modification, Test 3c

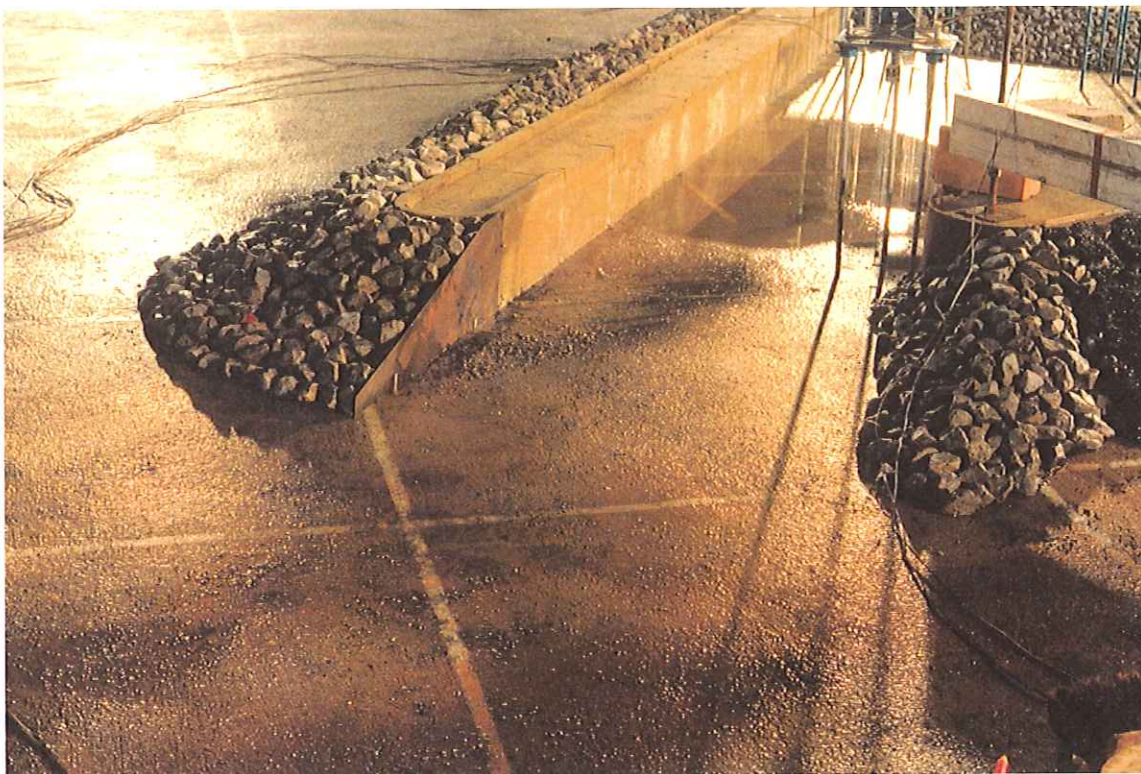
Plate 10 Vertical wall, entrance channel width 30m, Test 3g

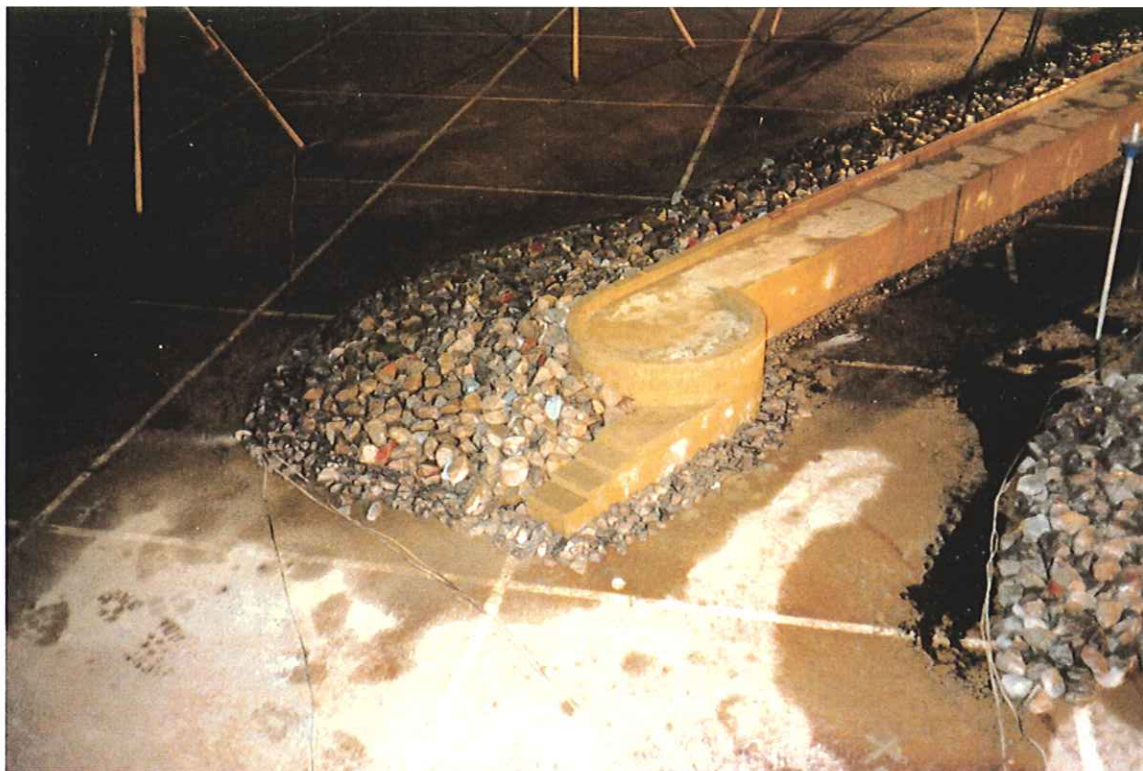
Plate 13a Roundhead detail after Test Series 6

Details of the structure assessed during Test Series 6 can be found in Figures 5-7 and Plates 12 and 13. Results of the armour movement in terms of the percentage number of rocks contained within the two layers of the test area are described in Tables 18-21.

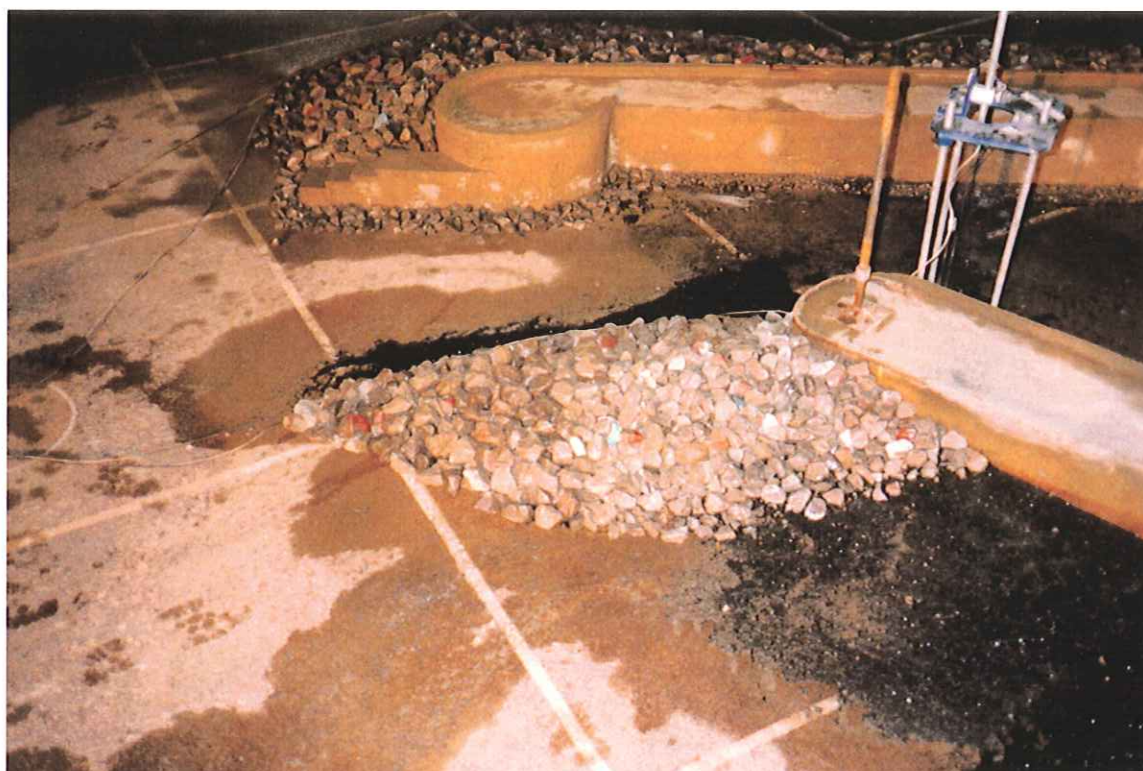
Plate 13b Roundhead and East Pier extension detail after Test Series 6

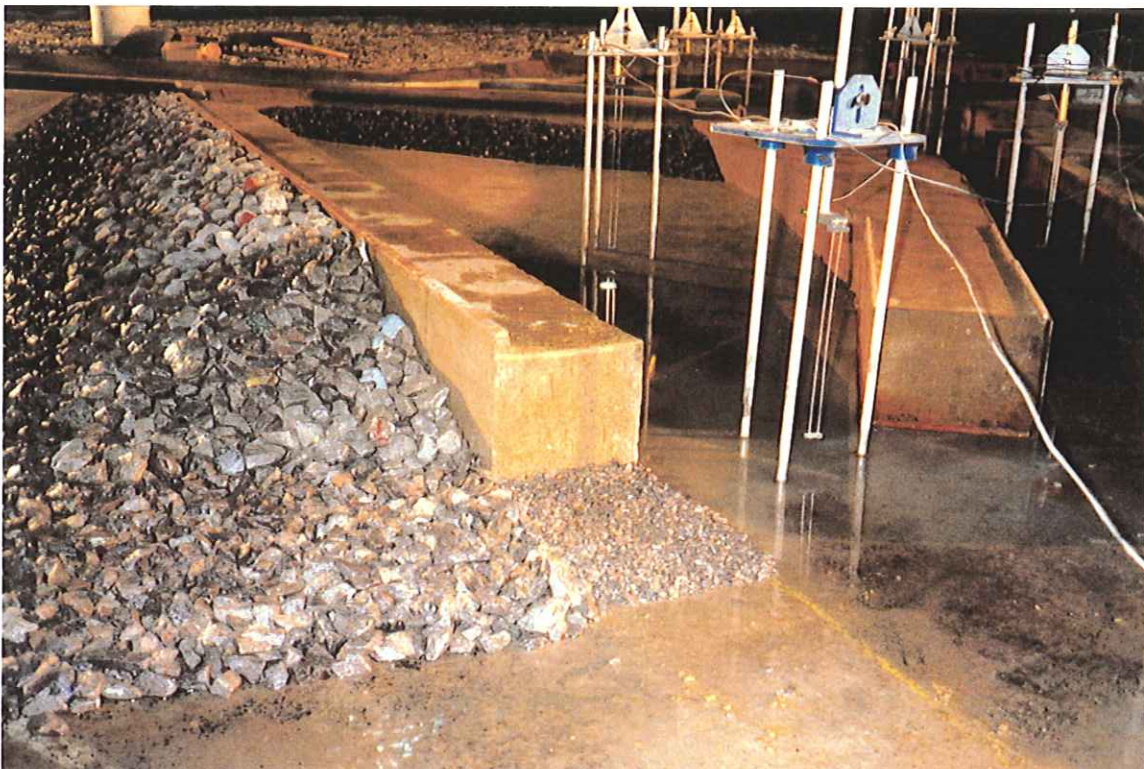
Plate 15 Construction phase tests, close-up of temporary works, Test Series 7a

During Test Series 7, tests were carried out to assess the performance of each of the two layouts during the 1:10 year storm event. The layouts represent two stages of the new West Breakwater construction, combined with the removal of the old West Pier. The layouts are shown in Figure 17 and Plates 14-17.

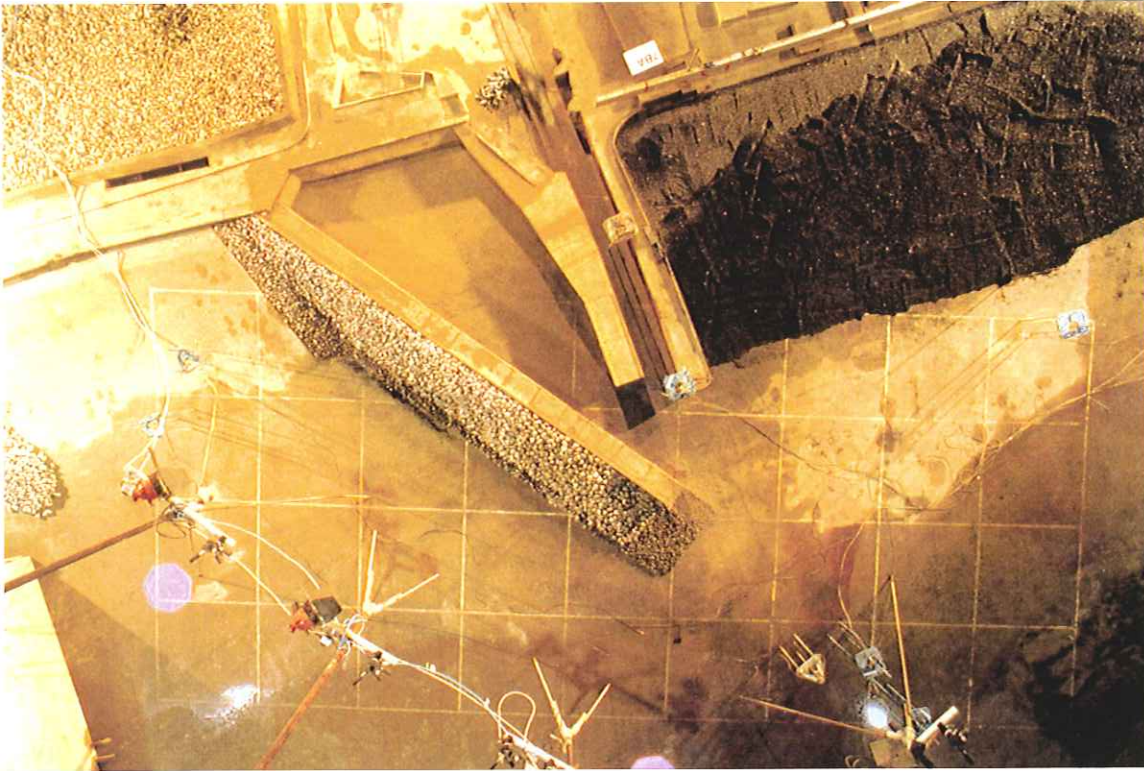
Plate 16 Construction phase tests, Test Series 7b

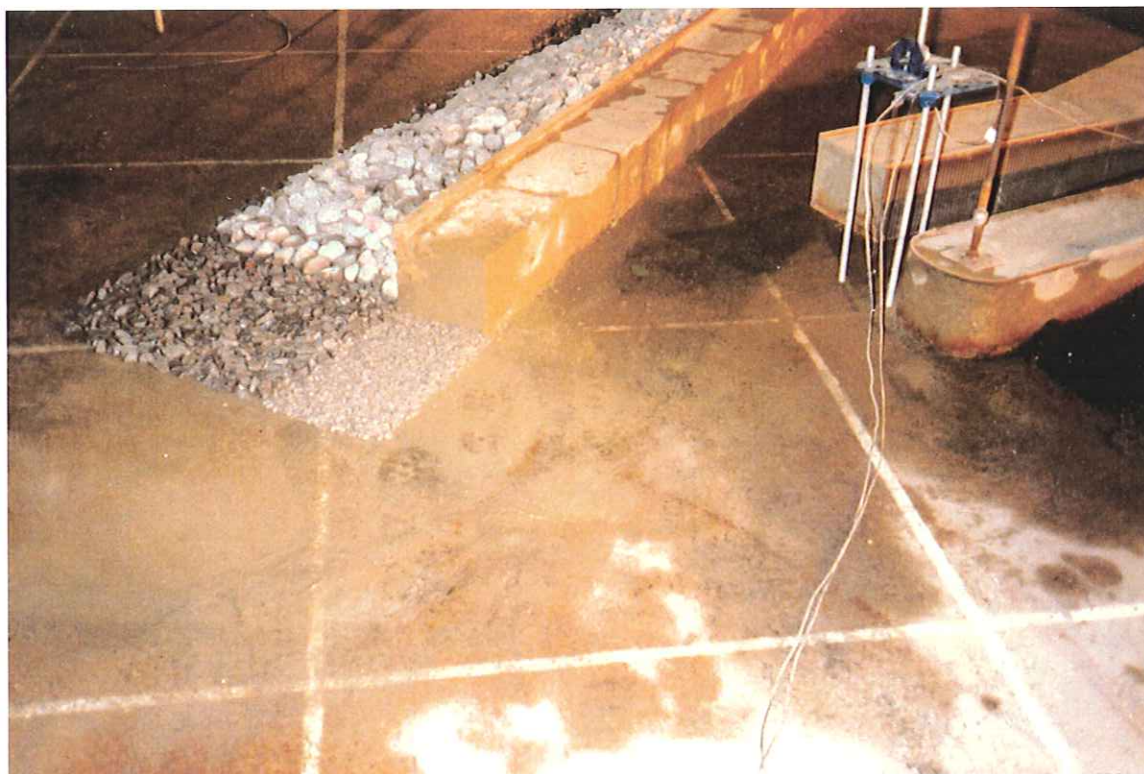
Plate 17 Construction phase tests, close-up of temporary works, Test Series 7b

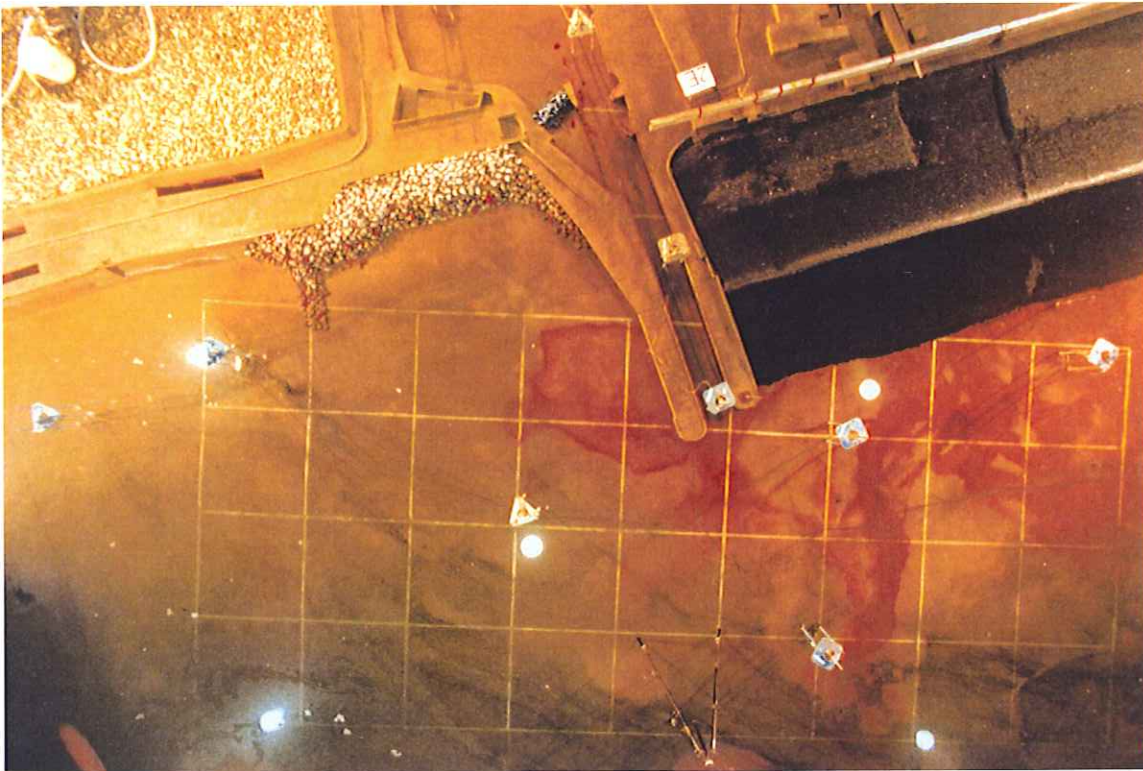
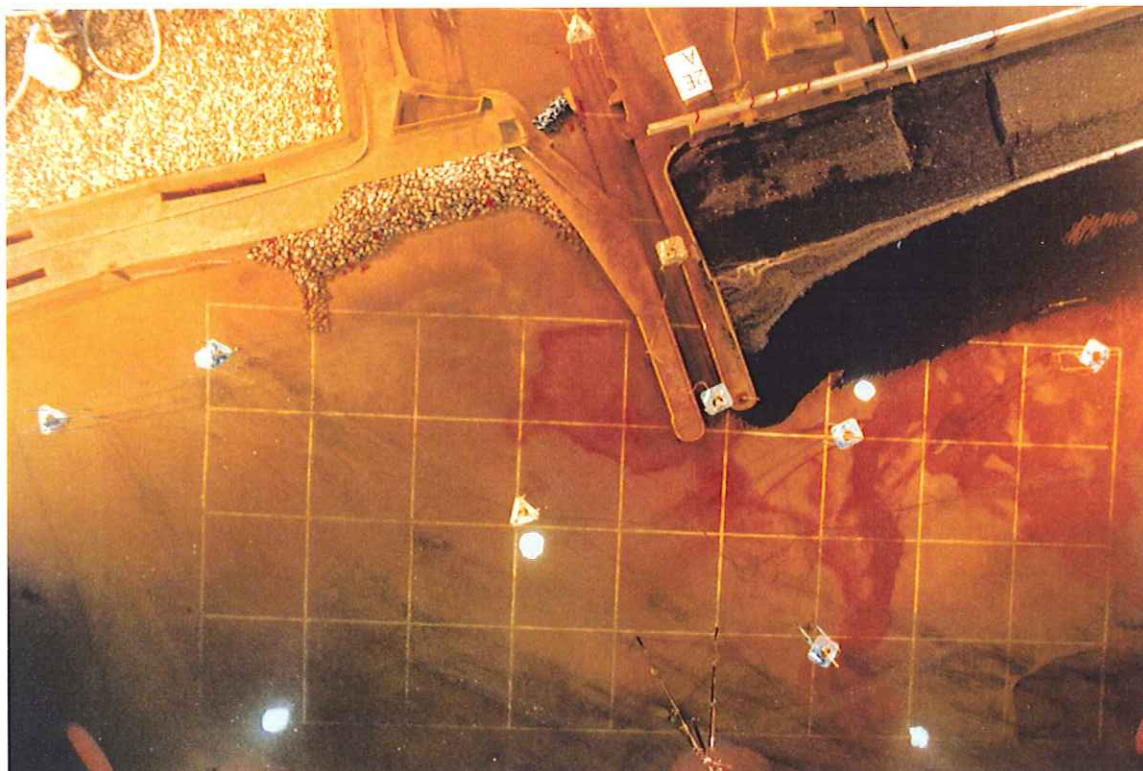
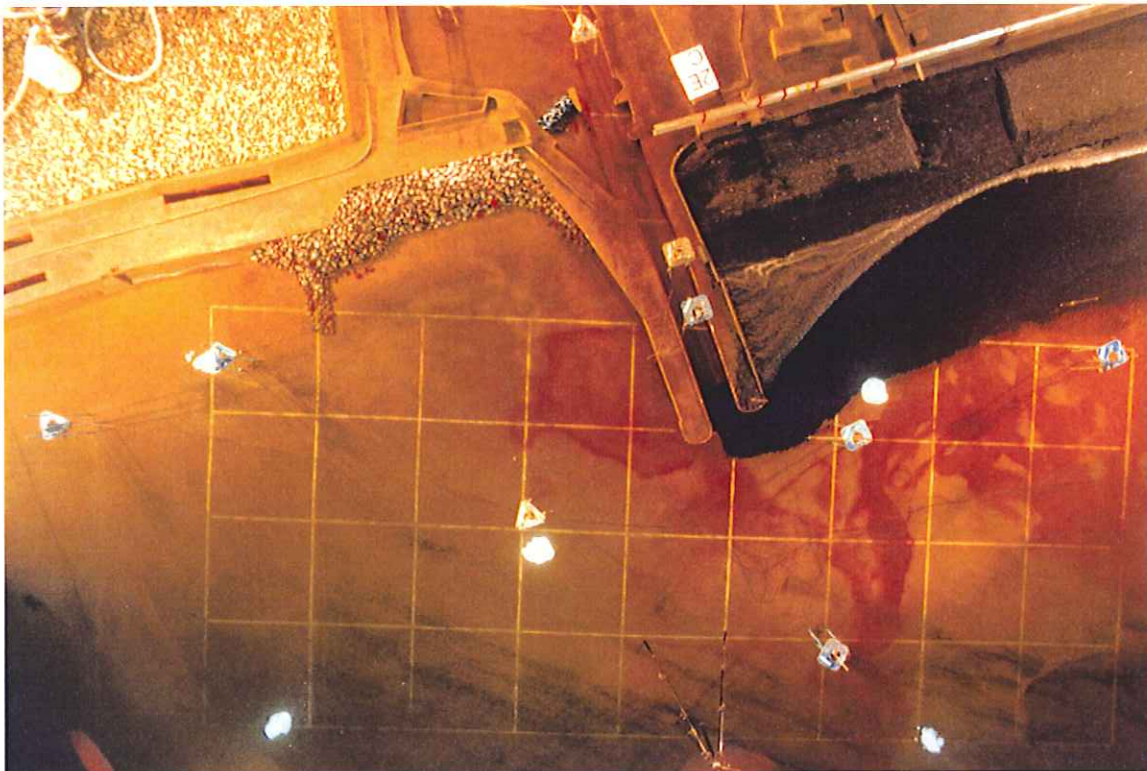
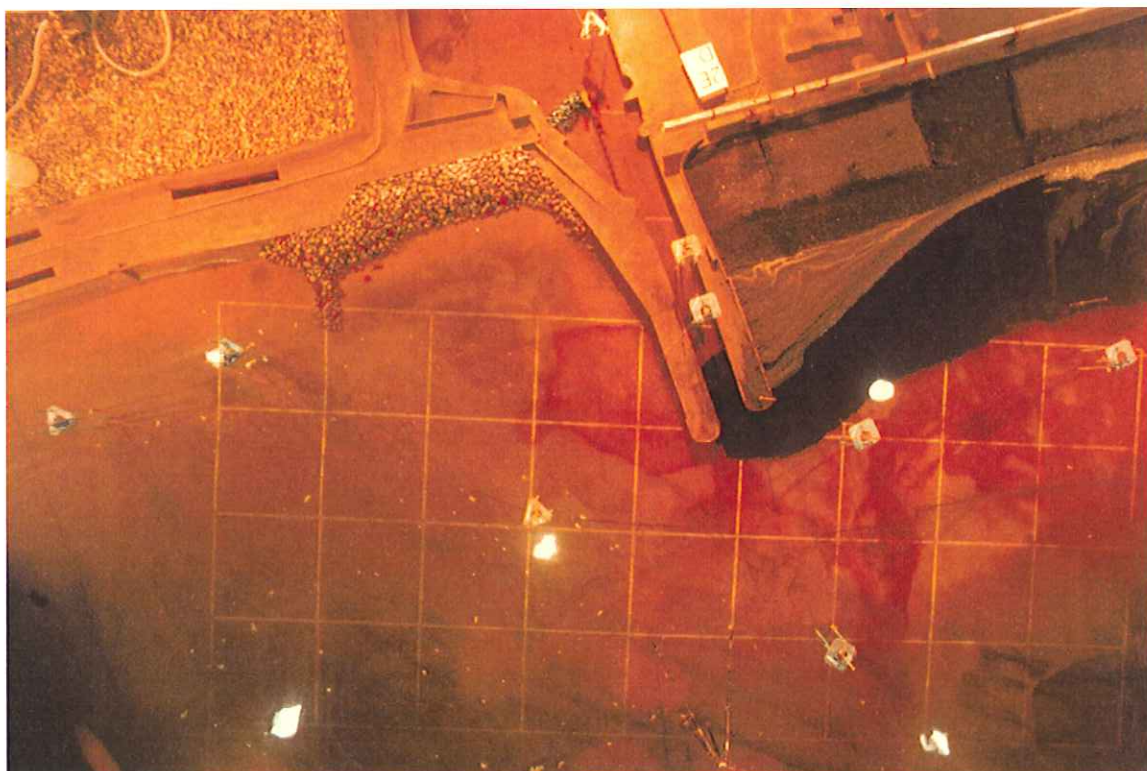
Plate 18a Accretion of the beach at the existing East Pier, waves from 160°N, pre-test

Plate 18b Accretion of the beach at the existing East Pier, waves from 160°N, prototype test duration 14.6 hours

Plate 18c Accretion of the beach at the existing East Pier, waves from 160°N, prototype test duration 43.7 hours

Plate 18d Accretion of the beach at the existing East Pier, waves from 160°N, prototype test duration 58.3 hours

The build up of the East Beach against the existing East Pier, for waves from the south east, is shown in Plates 18a-d. The build up is relatively fast allowing the shingle material to pass the tip of the East Pier and deposit in the harbour entrance. It is interesting to note that no material passed the existing West Pier during any of the tests.
