West Bay Coastal Defence and Harbour Improvement Scheme

Physical Model Study

Report EX4064
January 2000

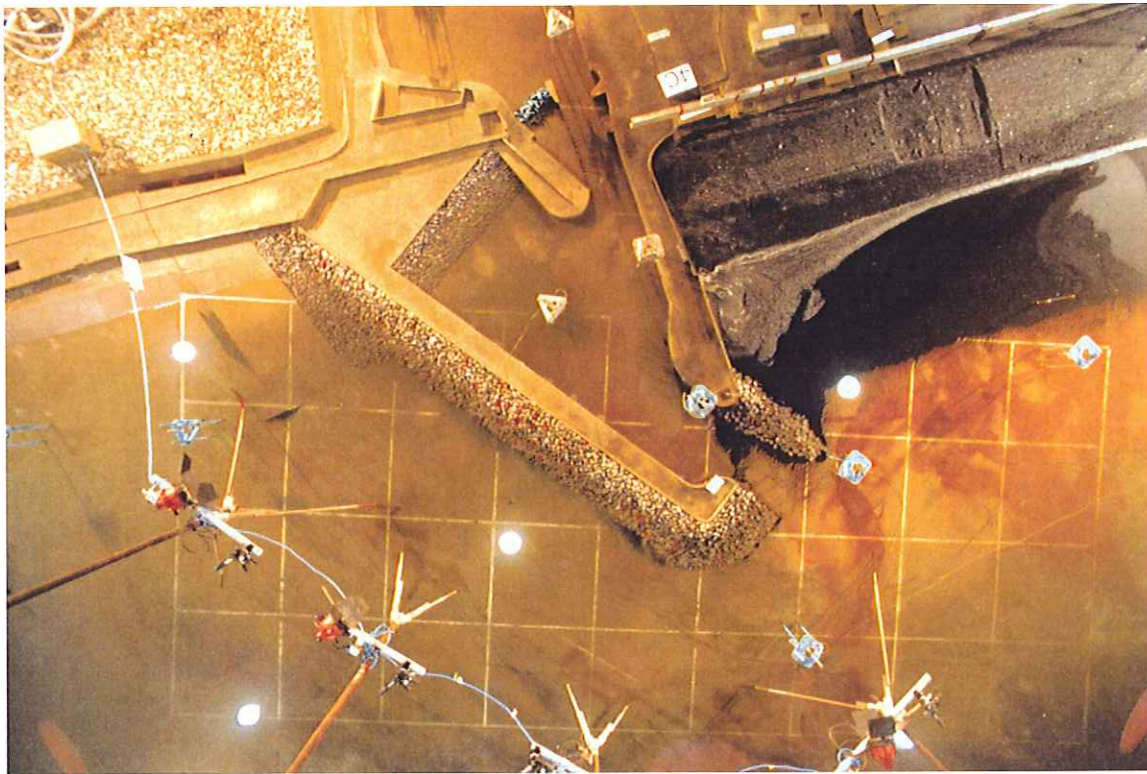
Plate 19a Accretion of the beach at the extended East Pier, waves from 160°N, prototype test duration 31.8 hours

Plate 19b Accretion of the beach at the extended East Pier, waves from 160°N, prototype test duration 70.0 hours

Plate 19c Accretion of the beach at the extended East Pier, waves from 160°N , prototype test duration 90.2 hours

The new West Breakwater and East Pier extension provided a sediment trap for waves from 160°N (Plates 19a-c). The increased length of the East Pier extension allows the beach to accumulate before bypassing the rubble mound structure. The wider shingle beach will act as an additional flood defence and will therefore provide a higher standard of service to the town of West Bay.

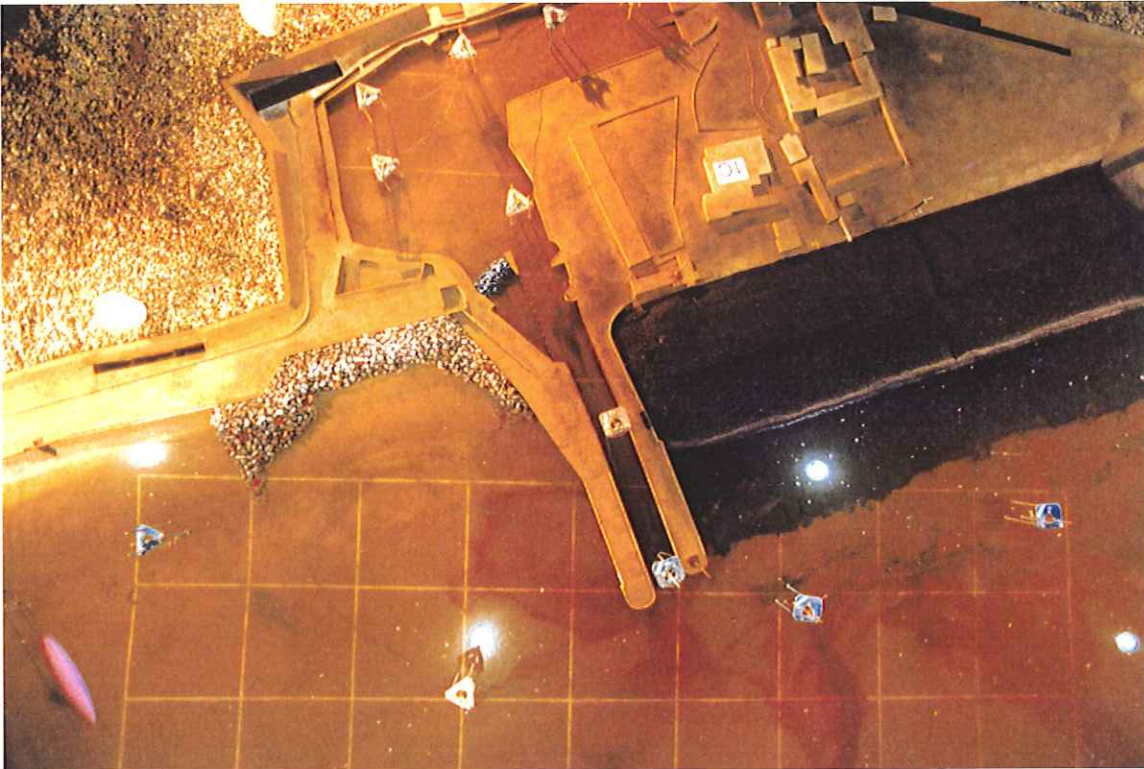
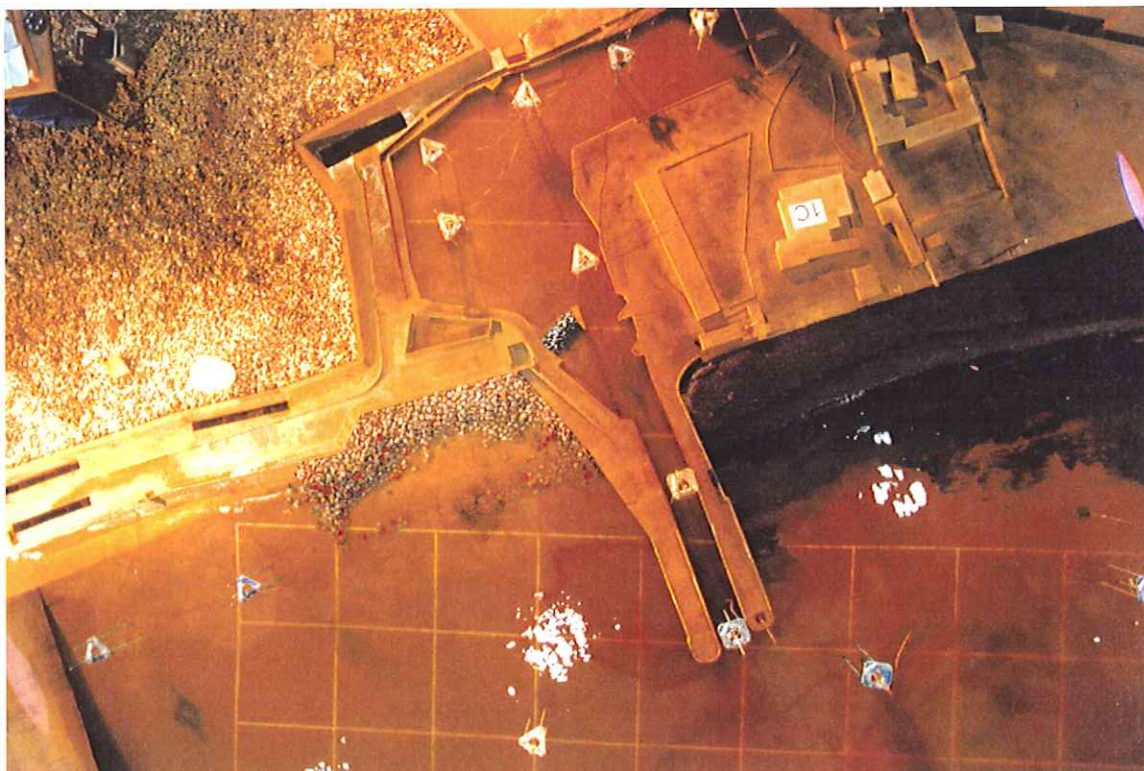
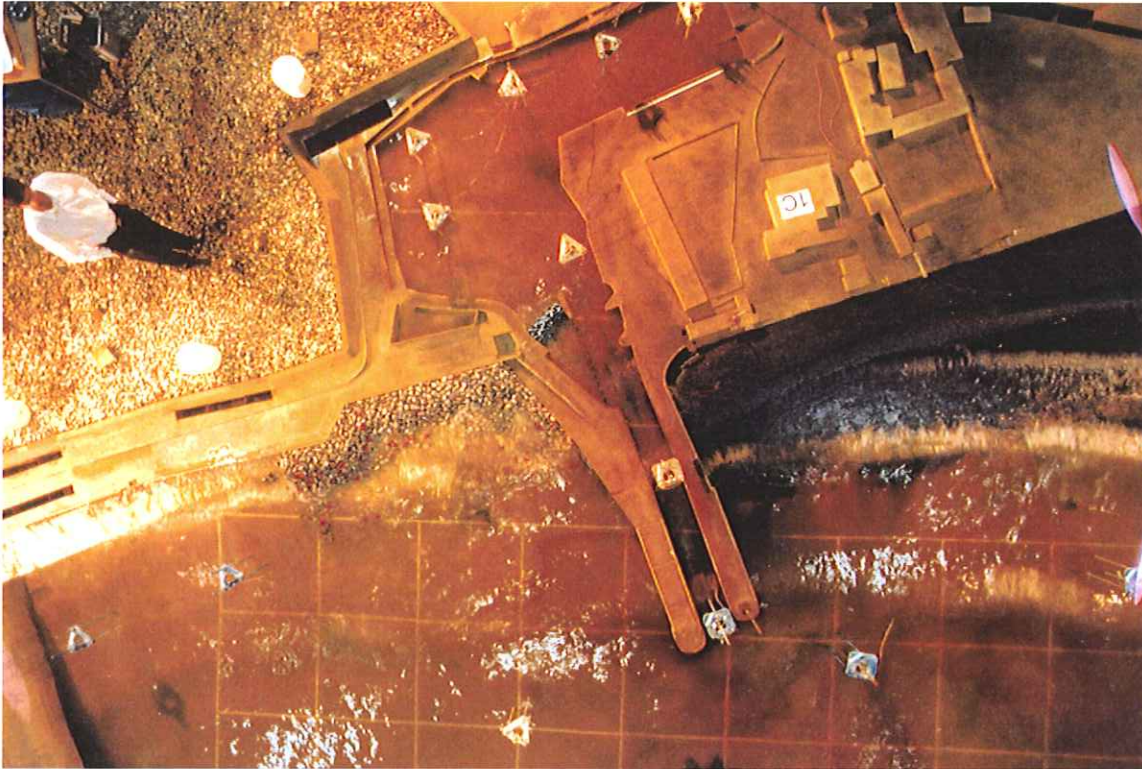
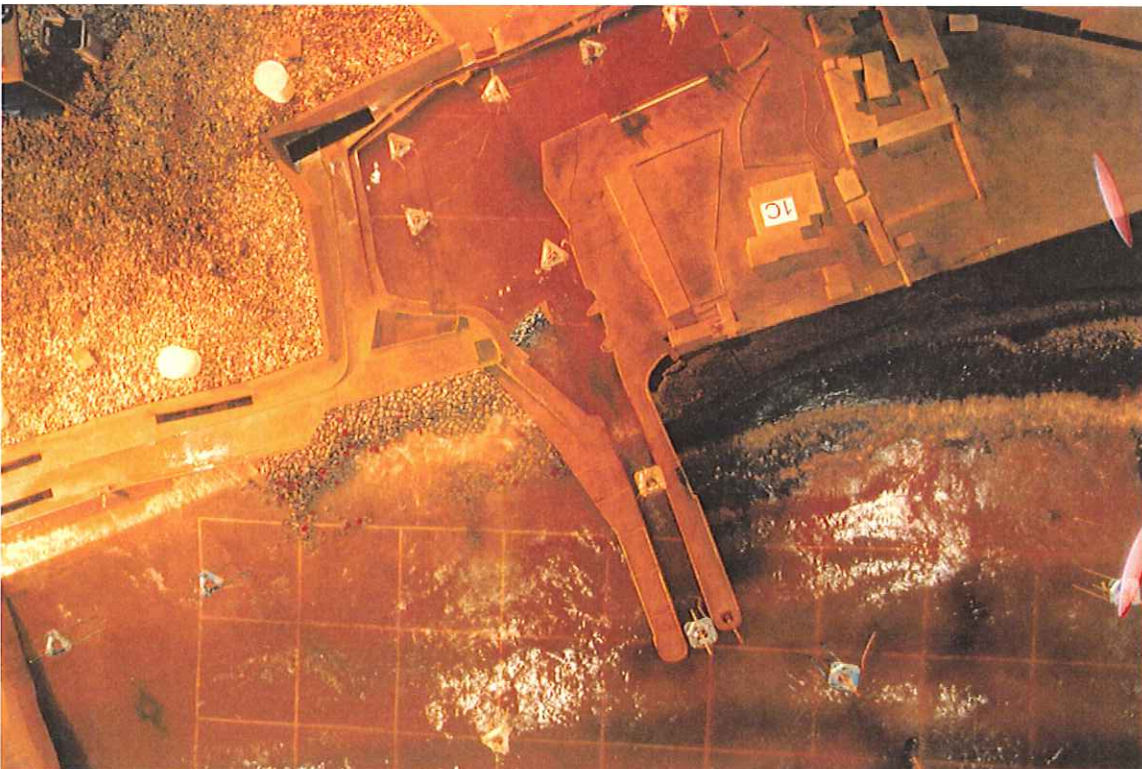
Plate 20a Erosion of the beach at the existing East Pier, waves from 220°N, pre-test

Plate 20b Erosion of the beach at the existing East Pier, waves from 220°N, prototype test duration 20.5 hours

Plate 20c Erosion of the beach at the existing East Pier, waves from 220°N, prototype test duration 57.3 hours

Plate 20d Erosion of the beach at the existing East Pier, waves from 220°N, prototype test duration 89.4 hours

The existing East Pier provides some shelter to the East Beach for waves from the south west. A relatively rapid erosion of the East Beach in front of West Bay is shown in Plates 20a-d for the existing situation. The new West Breakwater and East Pier extension provides more shelter than the existing layout, however waves from the south west (Plates 21a-c) still pushed the beach in an easterly direction, this will therefore reduce the magnitude of beach re-cycling required as part of the beach management plan for East Beach.

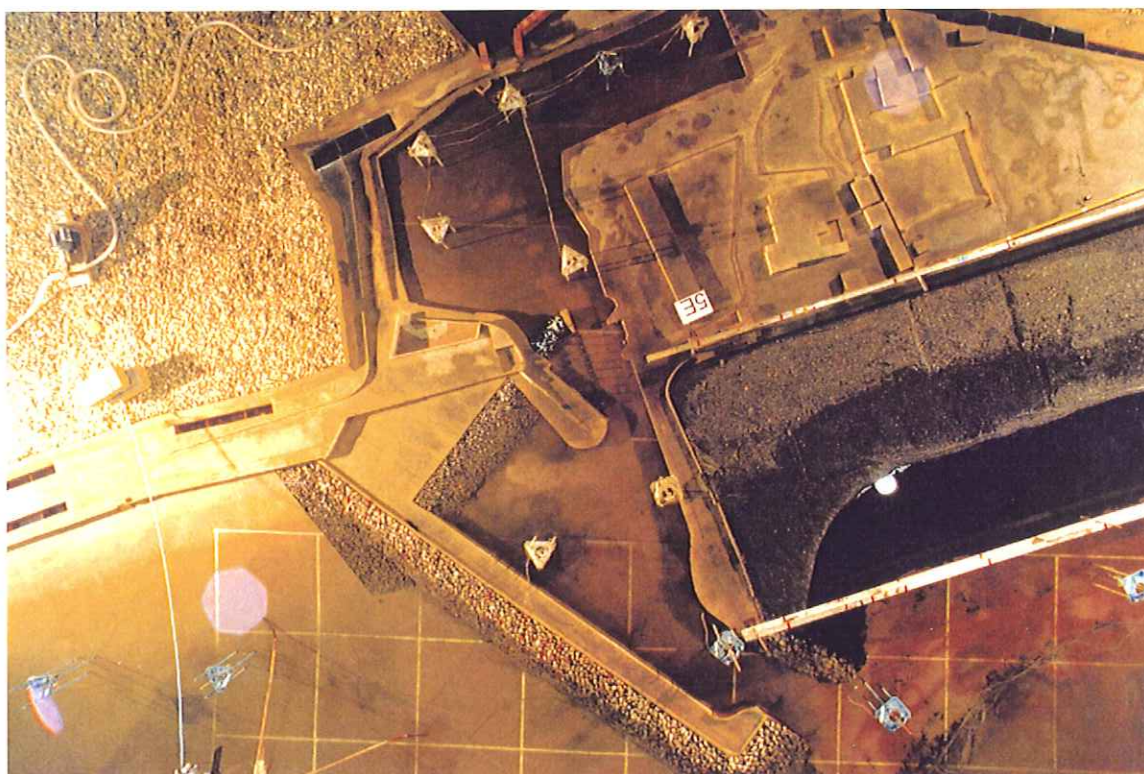
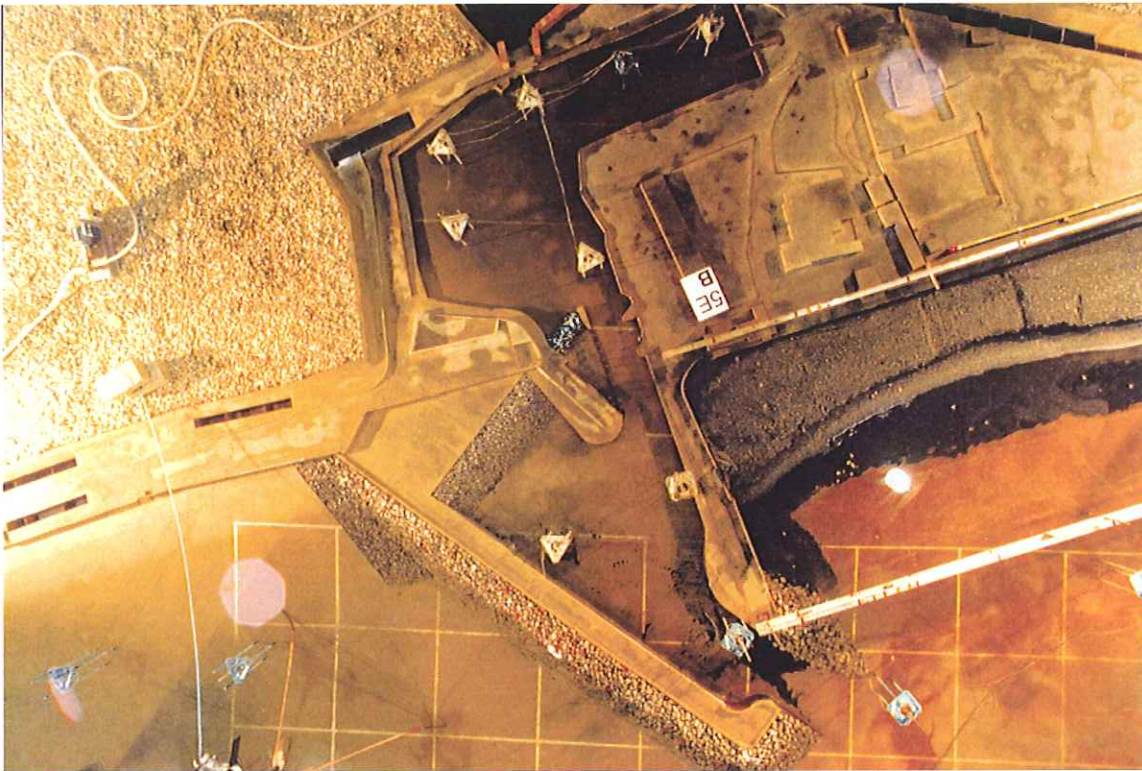
Plate 21a Erosion of the beach at the extended East Pier, waves from 220°N, pre-test

Plate 21b Erosion of the beach at the extended East Pier, waves from 220°N, prototype test duration 20.5 hours

Plate 21c Erosion of the beach at the extended East Pier, waves from 220°N, prototype test duration 42.8 hours

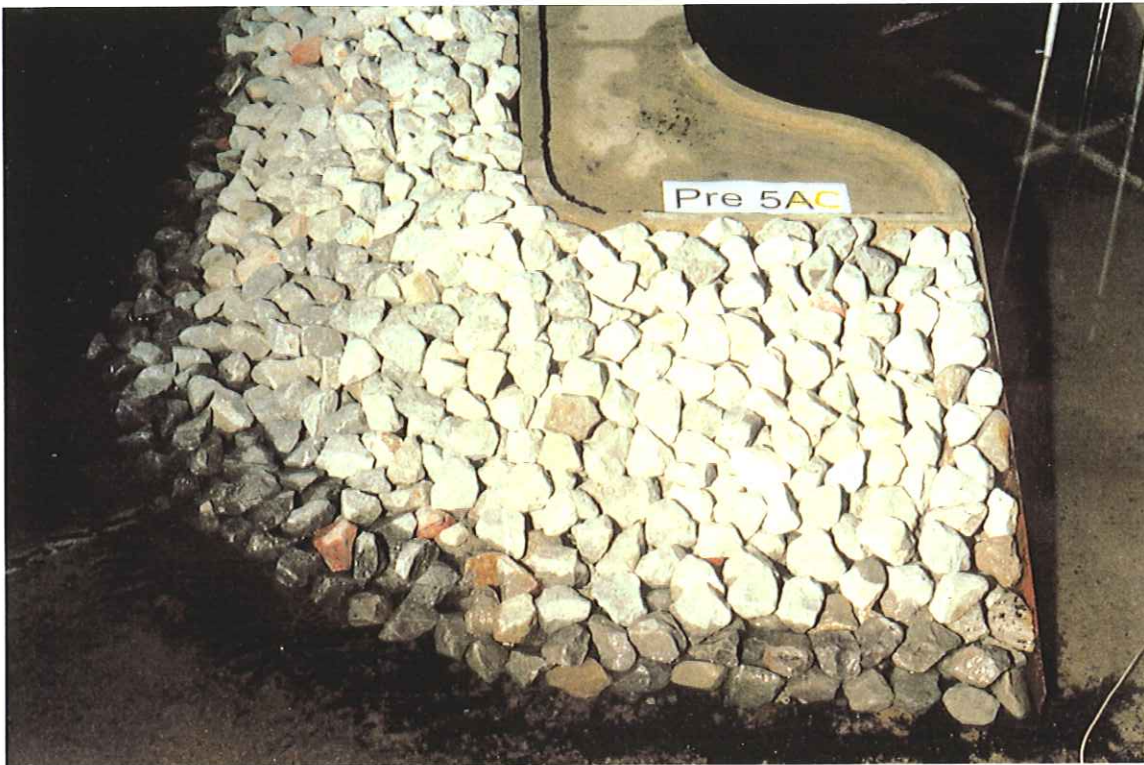
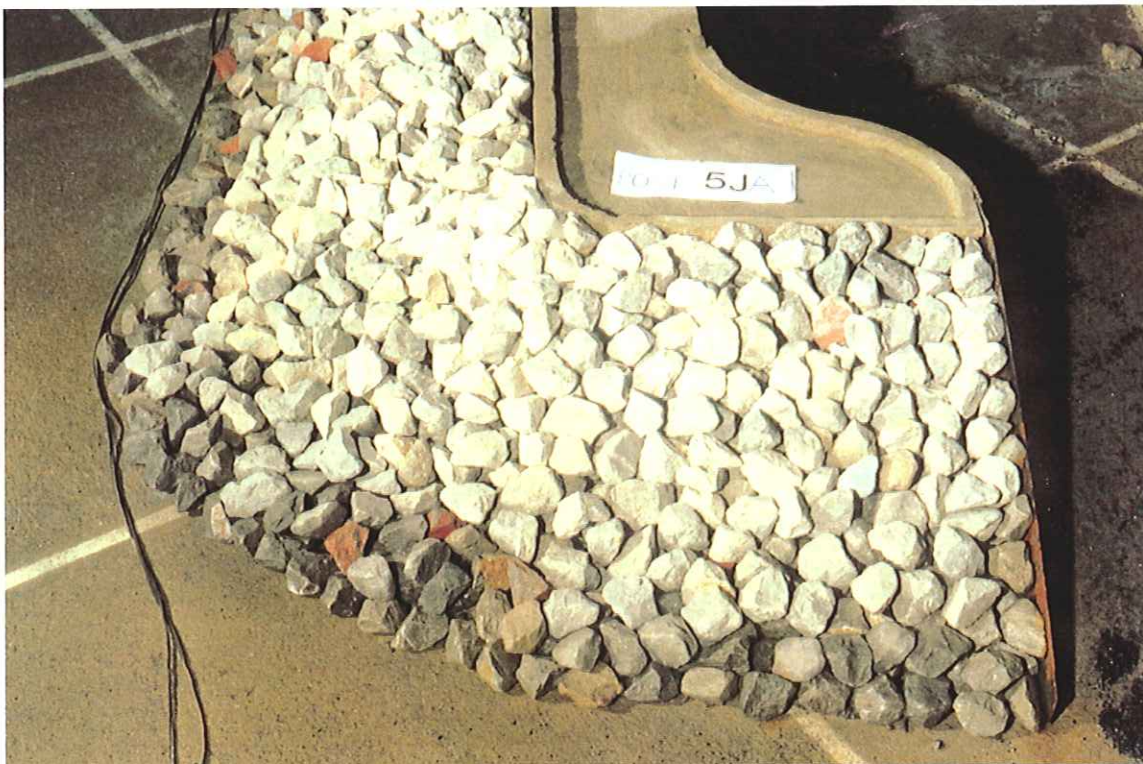
Plate 22a Roundhead before Test Series 5

Plate 22b Roundhead after Test Series 5

Armour stability was assessed at the roundhead and three other locations along the trunk of the new West Breakwater. There was evidence of some minor settlement on the slope at the SWL at all four locations. At one of the locations there was also noticeable movement of a group of 3-4 rocks adjacent to the crest. At the inshore location, a group of 3-4 toe rocks were moved during the course of testing. However at no location were any armour units removed from the slope and all locations indicated a stable slope at the end of testing (Plates 22A and 22B).

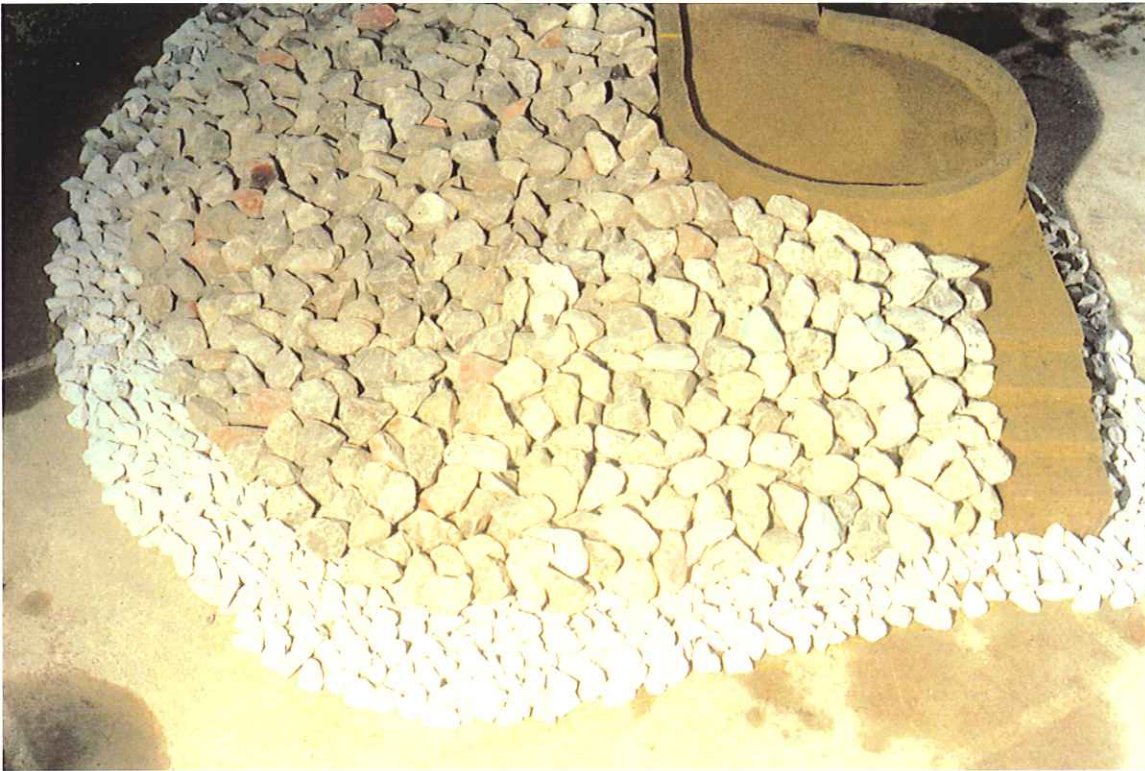
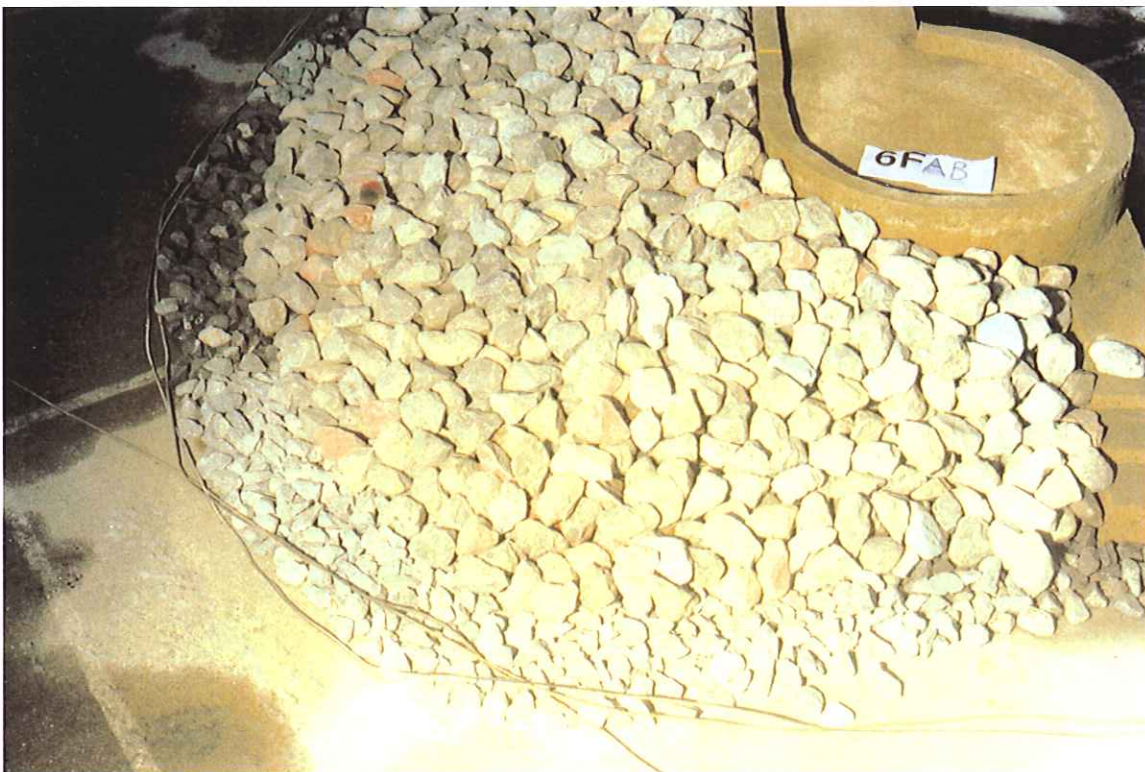
Plate 23a Roundhead before Test Series 6

Plate 23b Roundhead after Test Series 6

The greatest armour movement during Test Series 6 occurred on the seaward end of the West Breakwater roundhead where 2.3% of the rock units were extracted. Comparing this figure with the tolerable armour movement described in Section 5.2, the movement represents "Little - Moderate" damage. The armour movement during Test Series 6 was therefore acceptable (Plates 23a and 23b).
